White River Flowage 2024 Aquatic Plant Survey Report

October 29, 2024

Prepared for:
White River Flowage Lake Management District

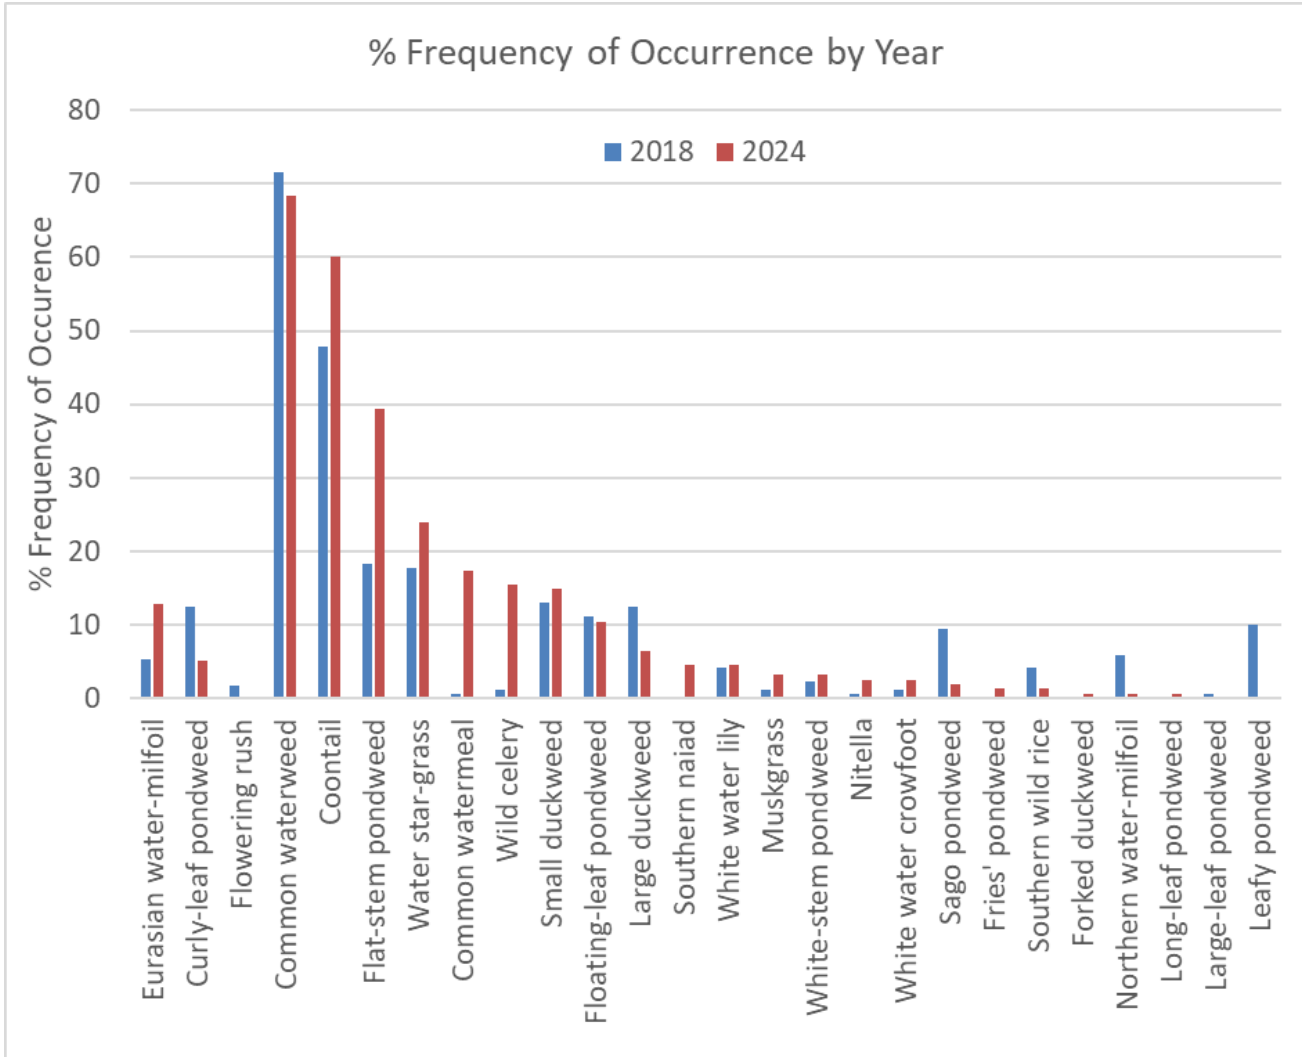
Table 2 in Appendix B includes the abundance statistics for each species from each survey. The following chart displays frequency of occurrence for the species sampled over time.
